ADVANCE REPORT
[on the]
SEDIMENTATION SURVEY OF LAKE CLINTON
CLINTON, OKLAHOMA

May 18 to June 14, 1938

Louis M. Glymph, Jr.

Sedimentation Studies
Office of Research
SCS-SS-35
July • 1940

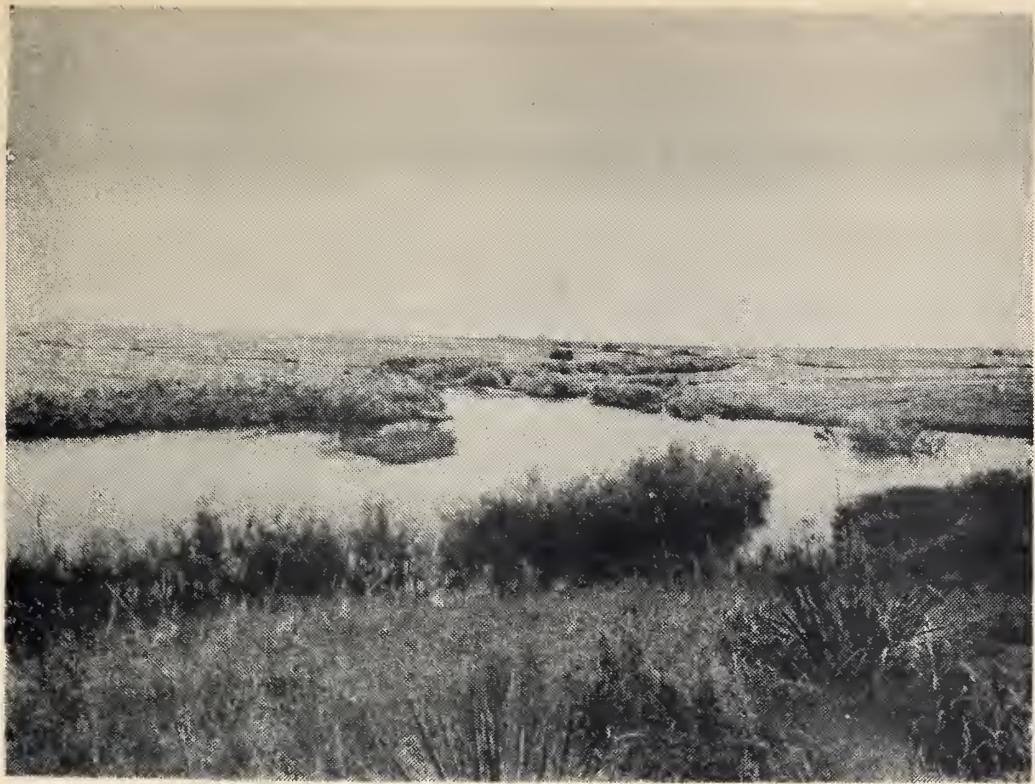
Figure 2.--Looking up the Turkey Creek arm of Lake Clinton, from top of hill just south of United States Highway No. 66. Note bars of sediment exposed with water level about 2 feet below spillway crest.

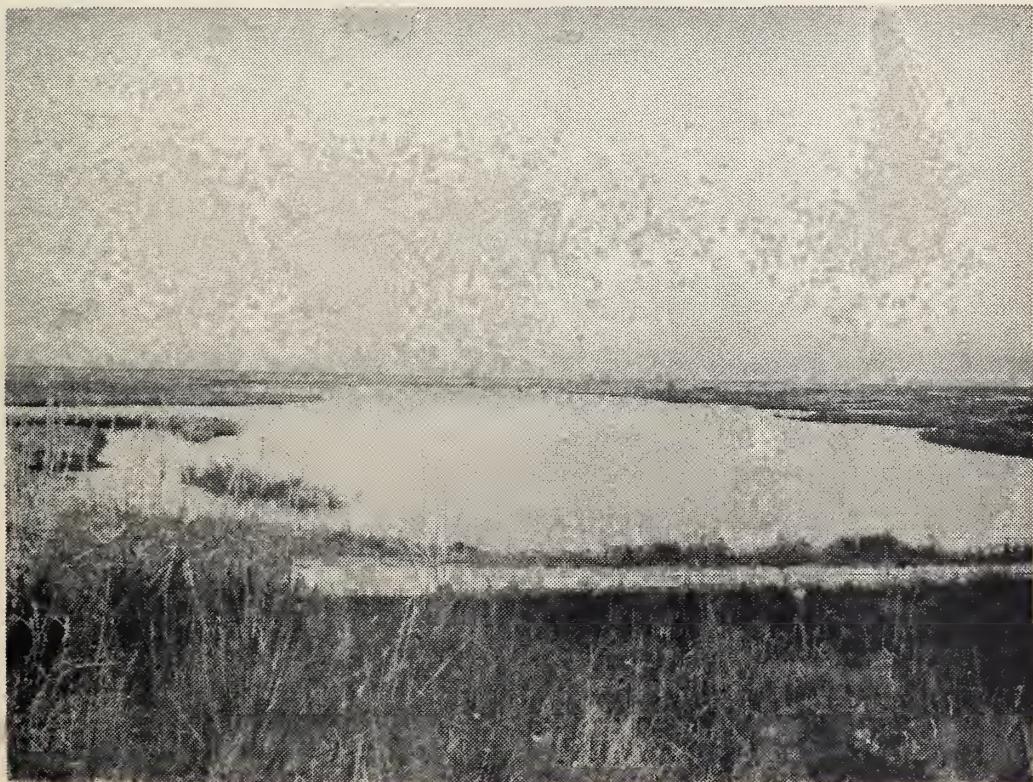
Figure 3.--A general view of the Turkey Creek arm, Lake Clinton, looking downstream from top of hill just south of United States Highway No. 66.

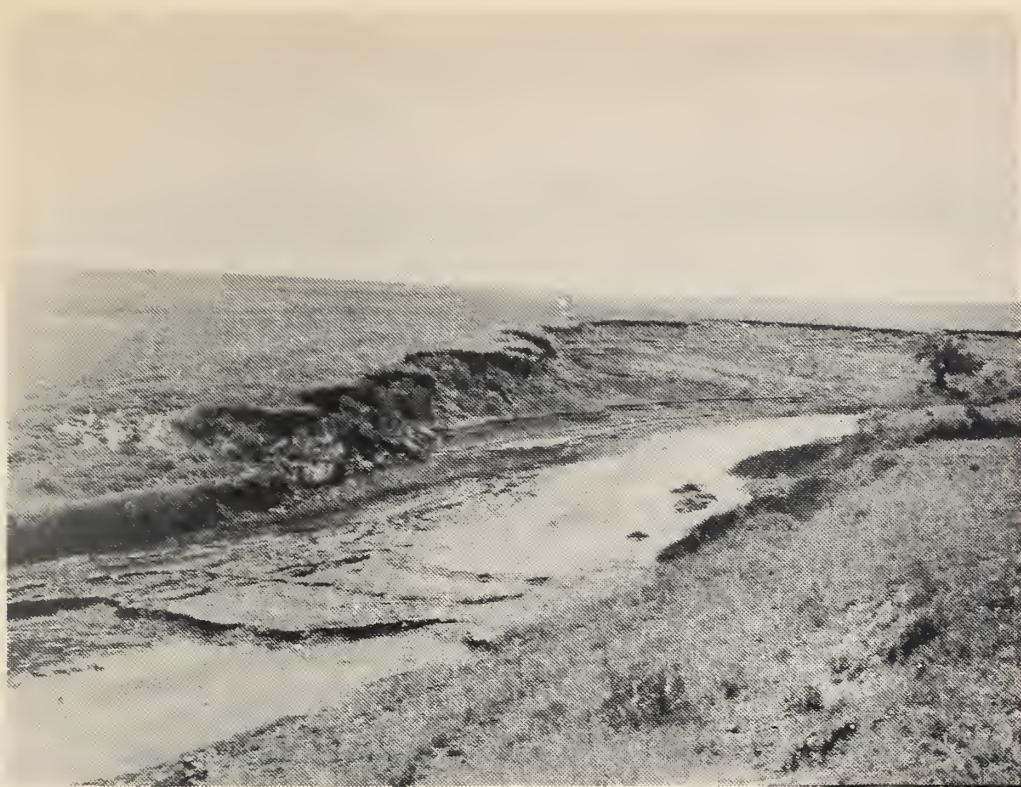
Figure 4.--Turkey Creek channel about 1 mile above the head of backwater of Lake Clinton. Note rock ledges in the stream bed and on the sloping bank.

Stream-bank erosion and sheet erosion on the steep slopes adjoining the main streams supply an appreciable quantity of soil material to the reservoir each year (fig. 4).

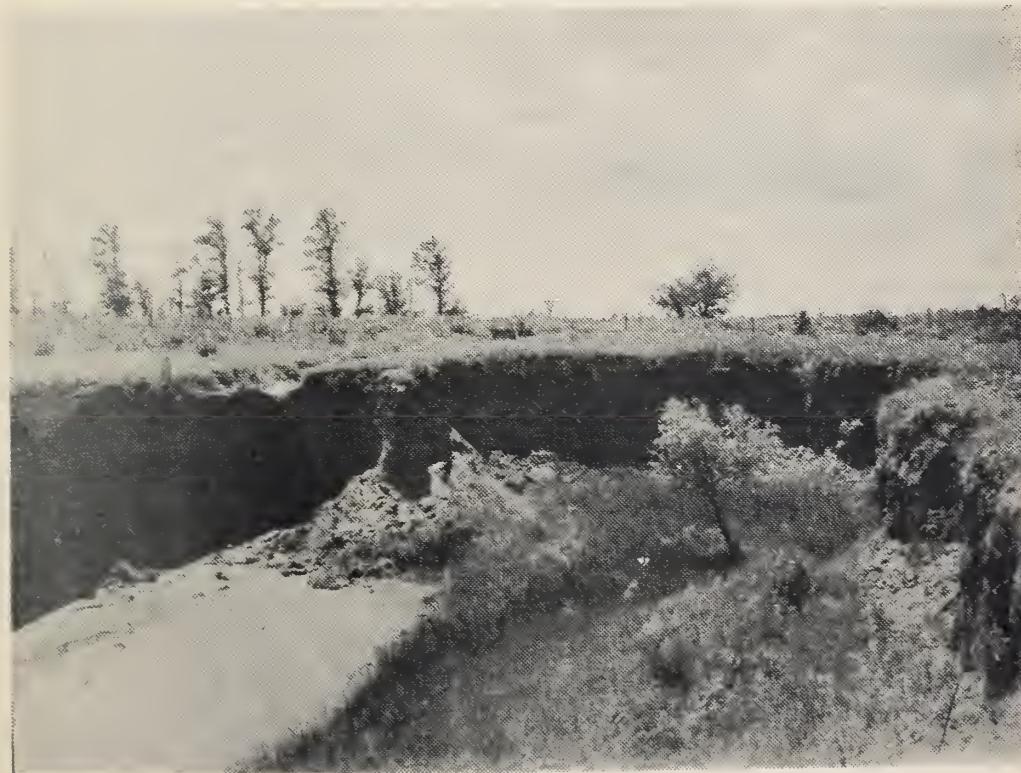
Figure 5.--The head of a gully in the Lake Clinton area. Gullies of this type are common in the area and supply a large amount of sediment to the reservoir.

About 90 percent of the drainage area has been affected to some extent by gully erosion, which process is a very important factor in the production of sediment moved into Lake Clinton. The many sizable gullies in the drainage area (fig. 5) and the areas destroyed by erosion (fig. 7, following p. 19) have undoubtedly supplied a large amount of the reservoir sediment. Roadbed and road-ditch erosion are closely related to gully erosion. Like many
